**Willow Creek Preserve  
Report Card  
2023**

Glacial Lakes Conservancy presents to you its very first Willow Creek Preserve Report Card detailing data from our 2022-2023 monitoring. In 2022-23, GLC staff, Ashley and Isabel, and volunteers completed training in accordance with Water Action Volunteers (WAV) protocols and training manuals to accurately and thoroughly collect valuable water quality data from Willow Creek Preserve in Sheboygan, WI. This was in addition to winter chloride sampling in 2022.

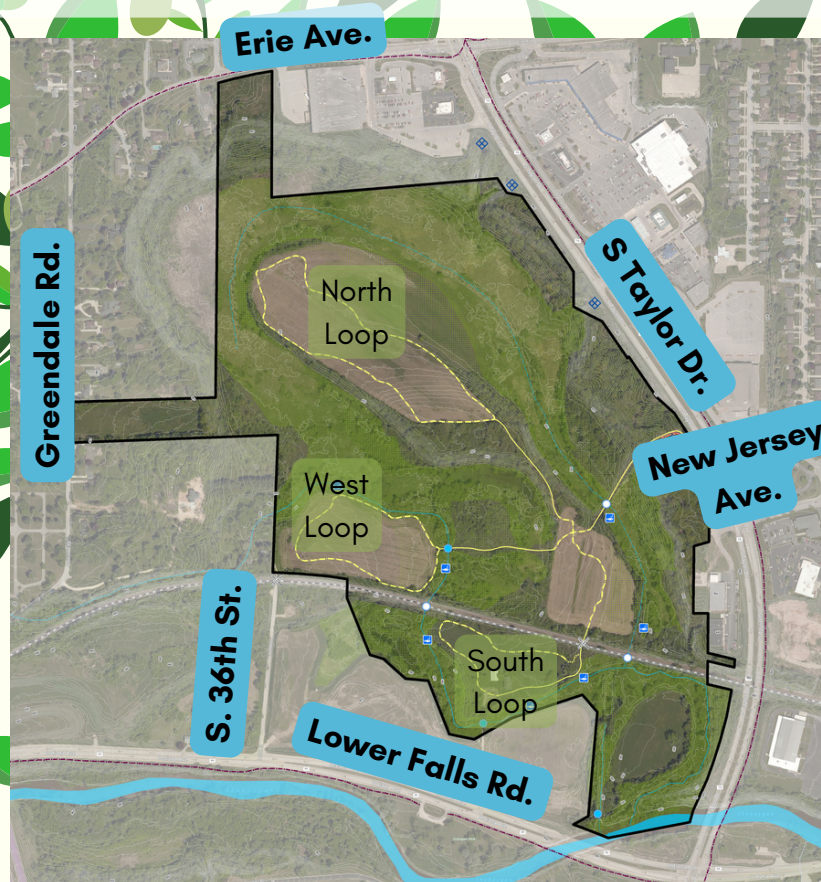
# Willow Creek Preserve Map

Willow Creek Preserve is a 143-acre lot, located in Sheboygan, WI. The Preserve lies in a former oxbow of the Sheboygan River, surrounded by steep, wooded slopes. The Preserve contains many ecosystems including wetlands, forest, fallow fields and more! Willow Creek itself is one of only two tributaries on the Sheboygan River, which is an Area of Concern, that can be accessed by Lake Michigan fisheries. Hence why it is such an important site to GLC! It wasn't until October 2018 that GLC acquired Willow Creek Preserve from the City of Sheboygan with funding provided by the Sheboygan River Natural Resources Damage Assessment (NRDA) settlement. The preserve's successes thus far would not be made possible without the contributions of the City and County of Sheboygan, the Wisconsin Department of Natural Resources (WDNR), and the many invested government and community stakeholders. Thanks to them, we now are working towards a healthier and more diverse Preserve.

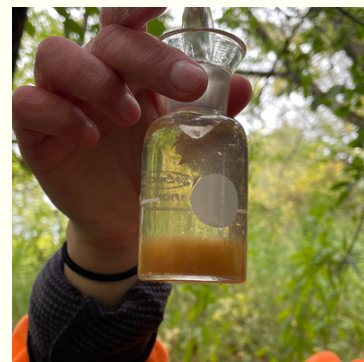
## Dissolved Oxygen (DO)

Dissolved Oxygen is measured using a Hach Kit. This kit utilizes drop count titration which can be done on site. Low DO levels are associated with poor water quality conditions. While adequate levels are necessary for species who reside in the water source.

**WDNR Surface Water Standard - >5 mg/L**

\*scale based on % of time the stream met this standard

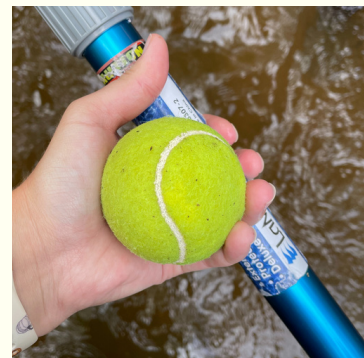
## Streamflow

Streamflow might be the most fun to measure on site! For this test, stream measurements are taken and then a float test is performed. During the float test, you will time the length of time in seconds it takes for a float (tennis ball) to make it 20ft within the waterway.

**Healthy Levels between 100-200 cubic square feet/ second**

\*scale based on % of time the streamflow fell in this bracket

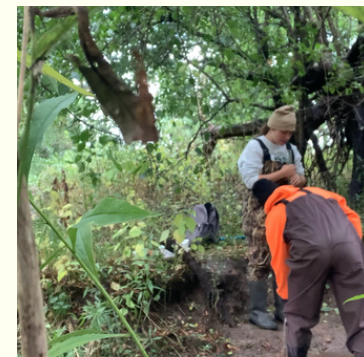
## Aquatic Index

Aquatic Indexing entails catching some critters that call the water home. While we were shocked in our October monitoring by the salmon run, that is not the normal! Typically, we are surveying riffles, leaf packs, undercut banks or snags of trees and roots.

**Rating Scale (based on presence/ absence survey)**

\*scale: F=0, D=1-1.5, C=1.6-2, B=2.1-2.5, A=2.6-3.5

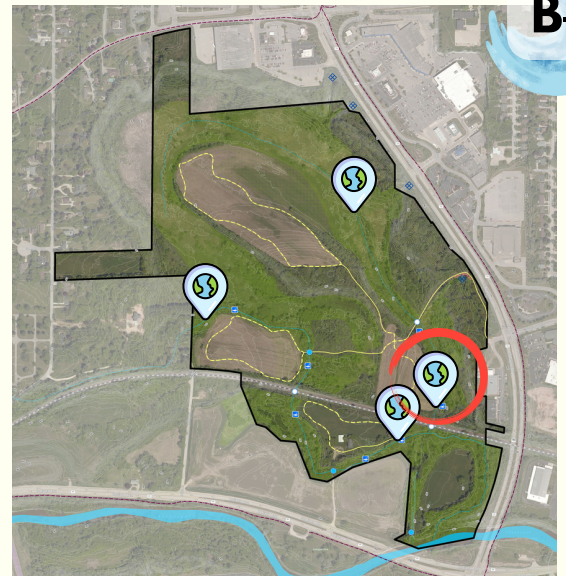
**Location #1**

Tributary 1 is located just before the railroad as you are walking towards the south loop of the Preserve. This tributary testing site is the last one prior to its confluence with Willow Creek, near the confluence to the Sheboygan River.

Latitude 43.74381190  
Longitude -87.74624370

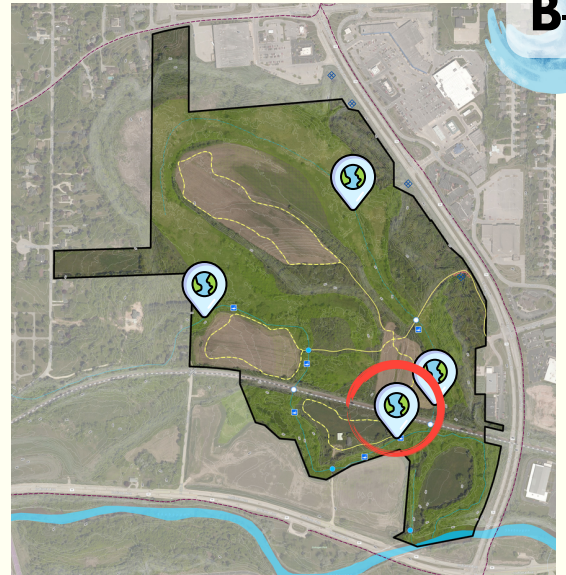
## Location #3

Willow Creek 1 testing location is accessible and encouraged to be accessed by trail users! This site is off of the trail headed toward the South Loop. This site also hosts our CrowdHydrology meter where trail users can input water level data for us while on a hike!

Latitude 43.74307610  
Longitude -87.74728740

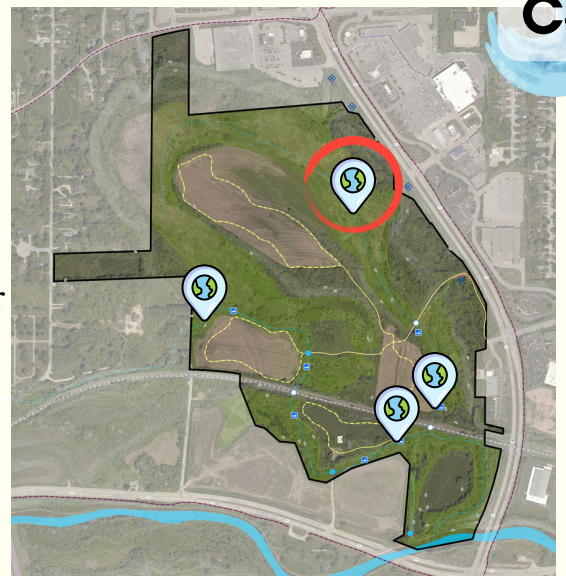
## Location #4

Tributary 2 is located in the thralls of no man's land! This site is located within the old Oxbow of the Sheboygan River. This site has typically lower water levels and lower DO levels. But has potential to serve species with restoration successes.

Latitude 43.74796930  
Longitude -87.74864790

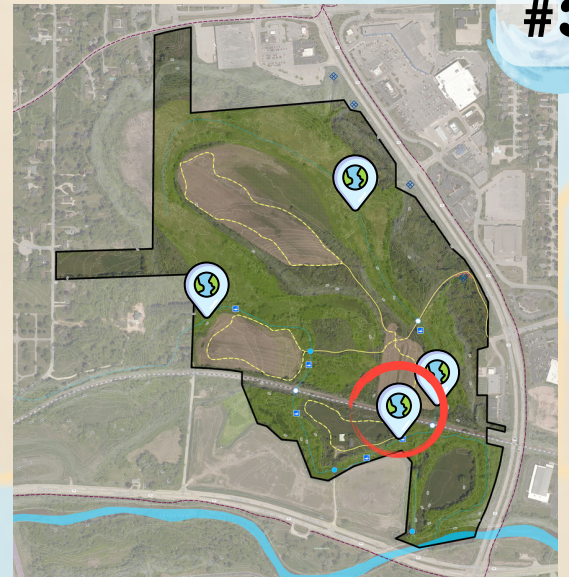
## Location #3 - WC1

**B<sup>-</sup>**

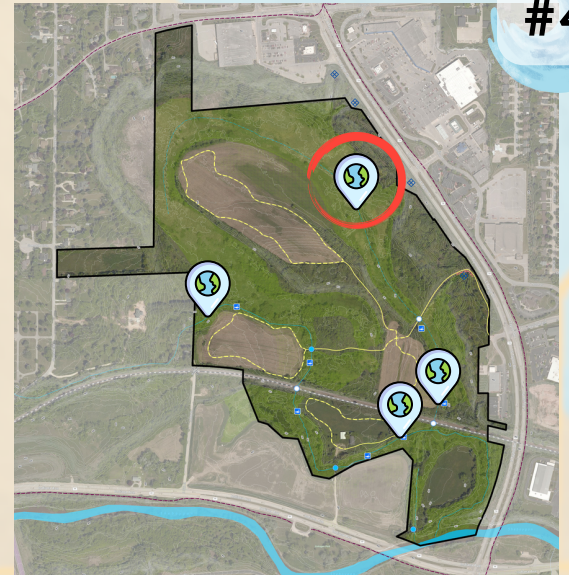
## Location #4 - Trib 2

D

A

C

C+
